RE: **REMEDIAL INVESTIGATION REPORT**
Buena Vista Township Public Works Yard
430 Union Road
Buena Vista Township, Atlantic County, New Jersey 08360
Block 7101, Lot 25
NJDEP Incident #: 15-09-24-0947-44
NJDEP SRP PI#: 032698

REMEDIAL INVESTIGATION REPORT

**BUENA VISTA TOWNSHIP PUBLIC WORKS YARD
430 UNION ROAD
BUENA VISTA TWP., ATLANTIC COUNTY, NJ
Block 7101, Lot 25**

NJDEP SRP PI # 032698

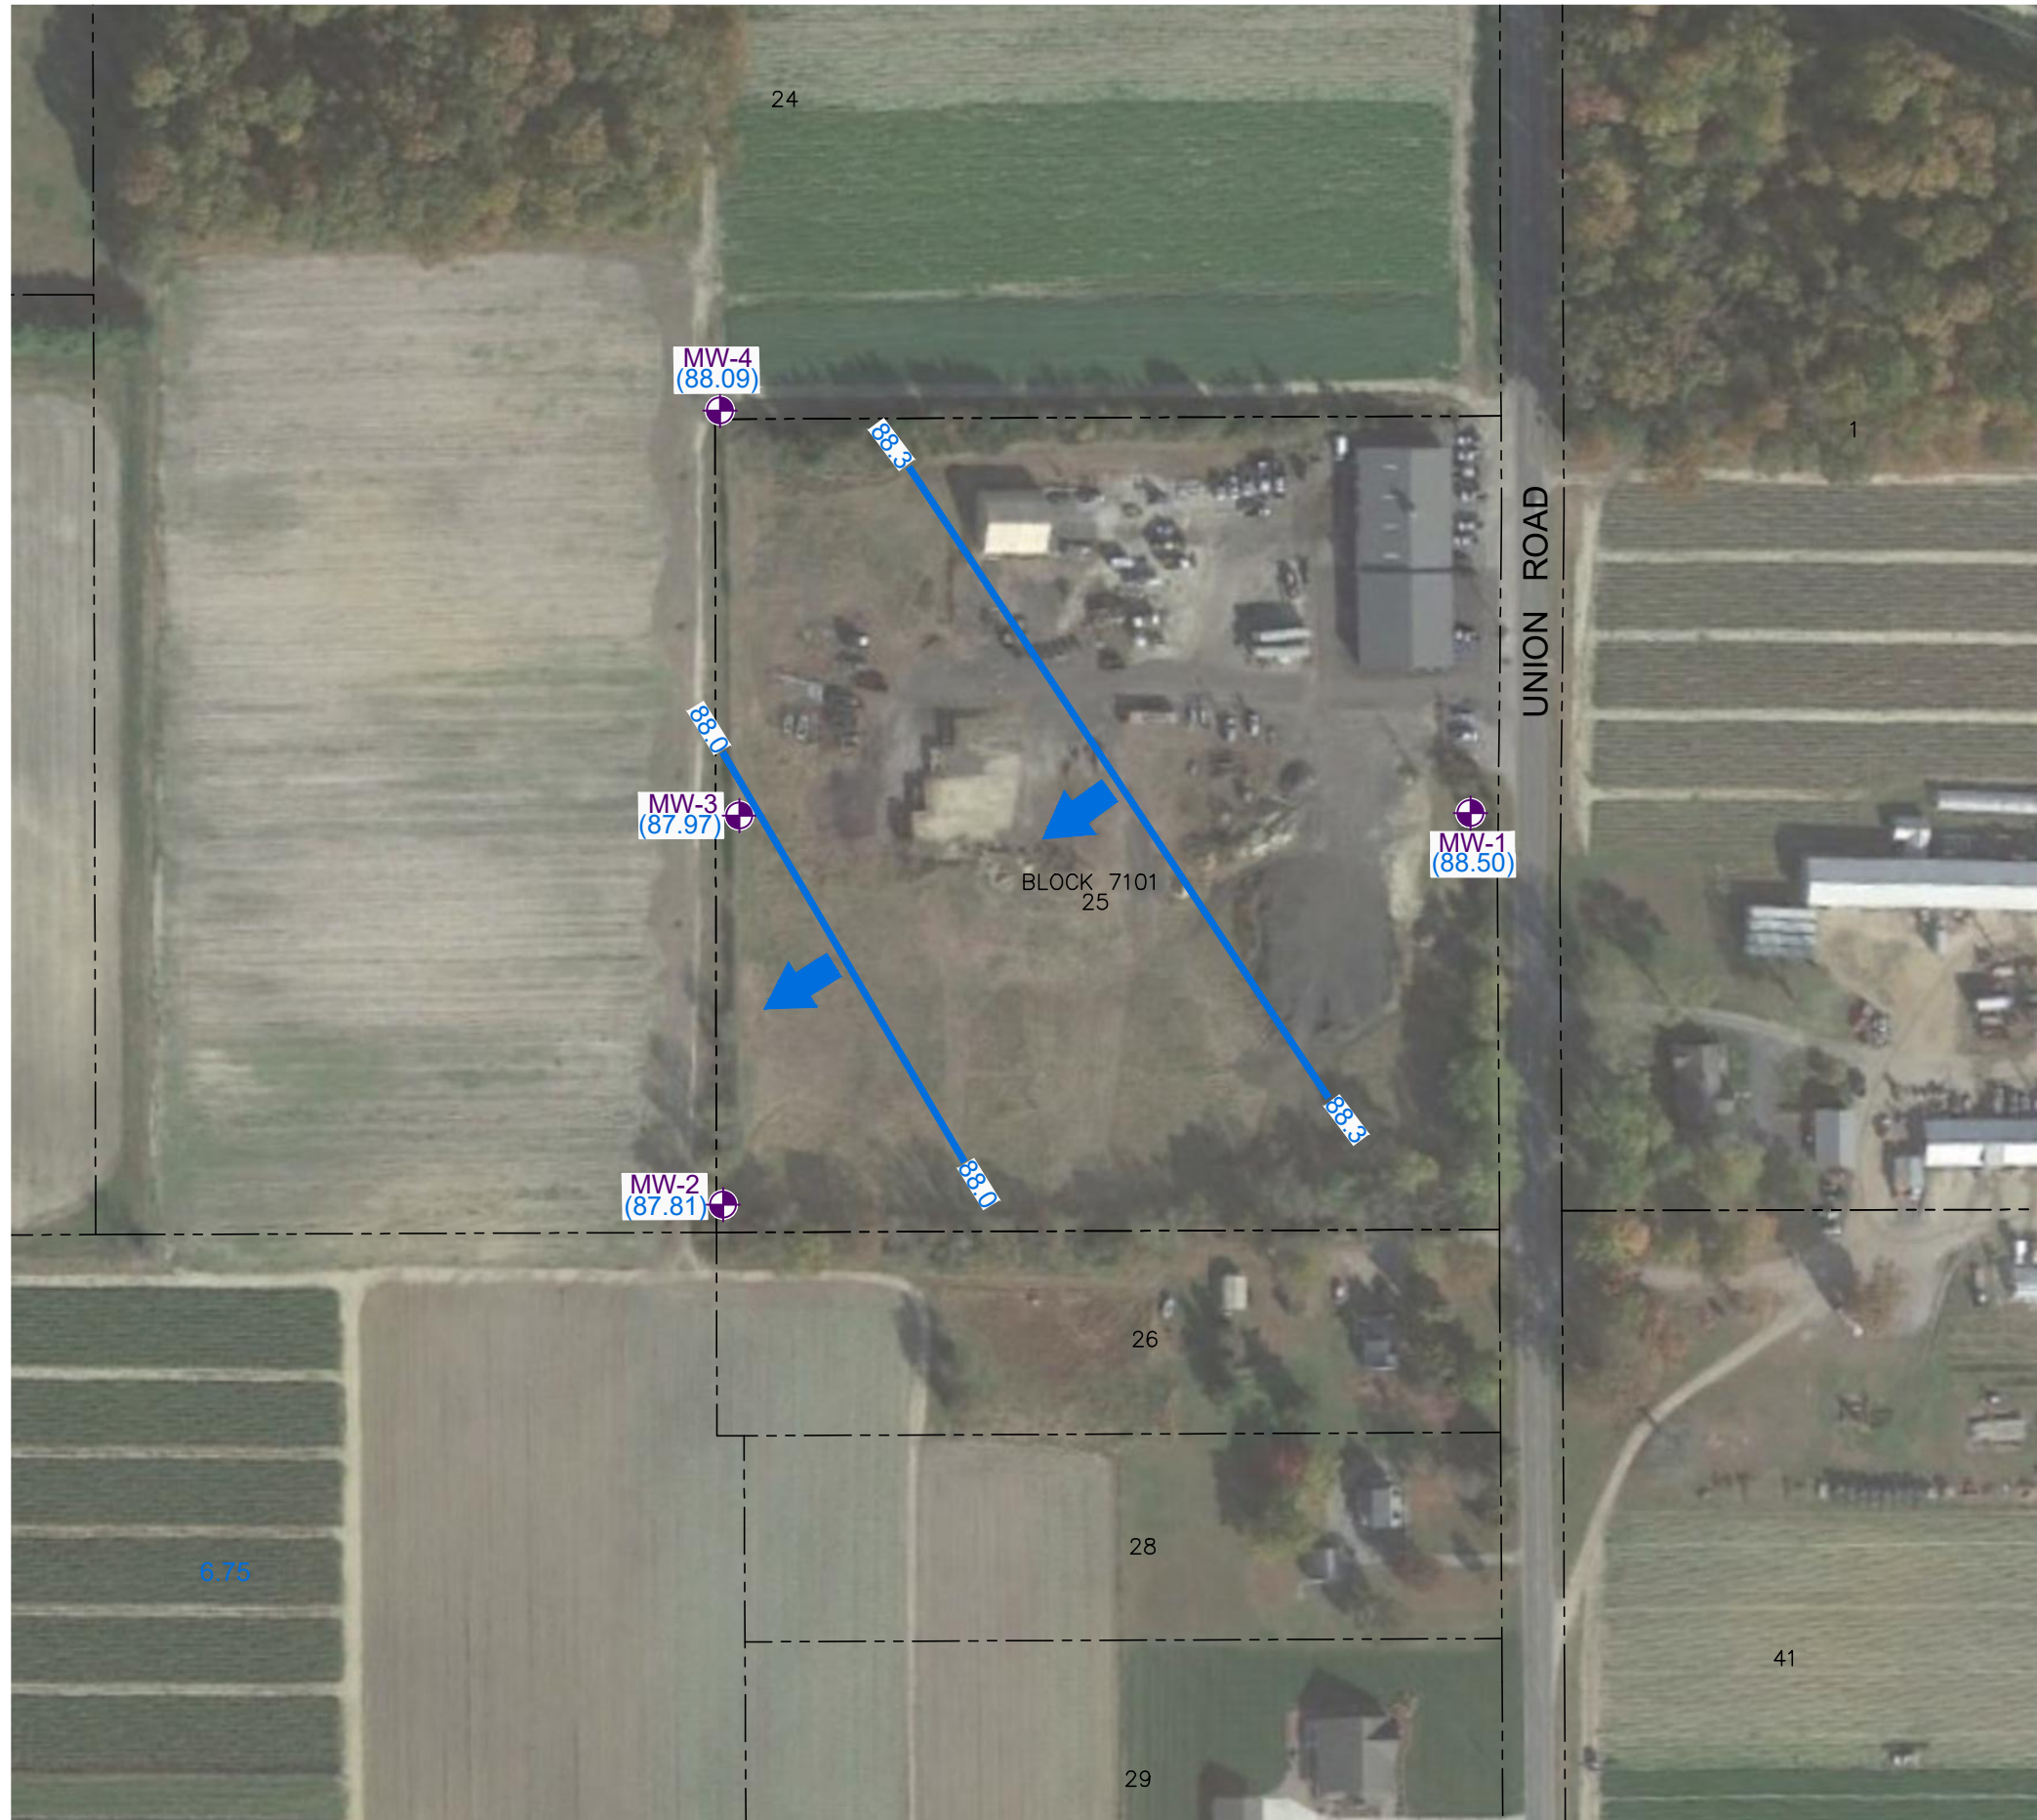
- LEGEND:**
- MONITORING WELL LOCATION
 - TAX BOUNDARY
 - 88.0 GROUNDWATER CONTOUR
 - (88.09) GROUNDWATER ELEVATION
 - GROUNDWATER FLOW DIRECTION

GROUNDWATER ELEVATION CONTOUR MAY 3, 2018	
BUENA VISTA TOWNSHIP PUBLIC WORKS YARD 430 UNION ROAD BUENA VISTA TOWNSHIP ATLANTIC COUNTY, NEW JERSEY	
CALMAR Associates LLC.	DATE: SEPTEMBER 2022
NJDEP SRP PI # 032698 Ryan K. Seibert, LSRP	SCALE: 1" = 150'
Figure 5

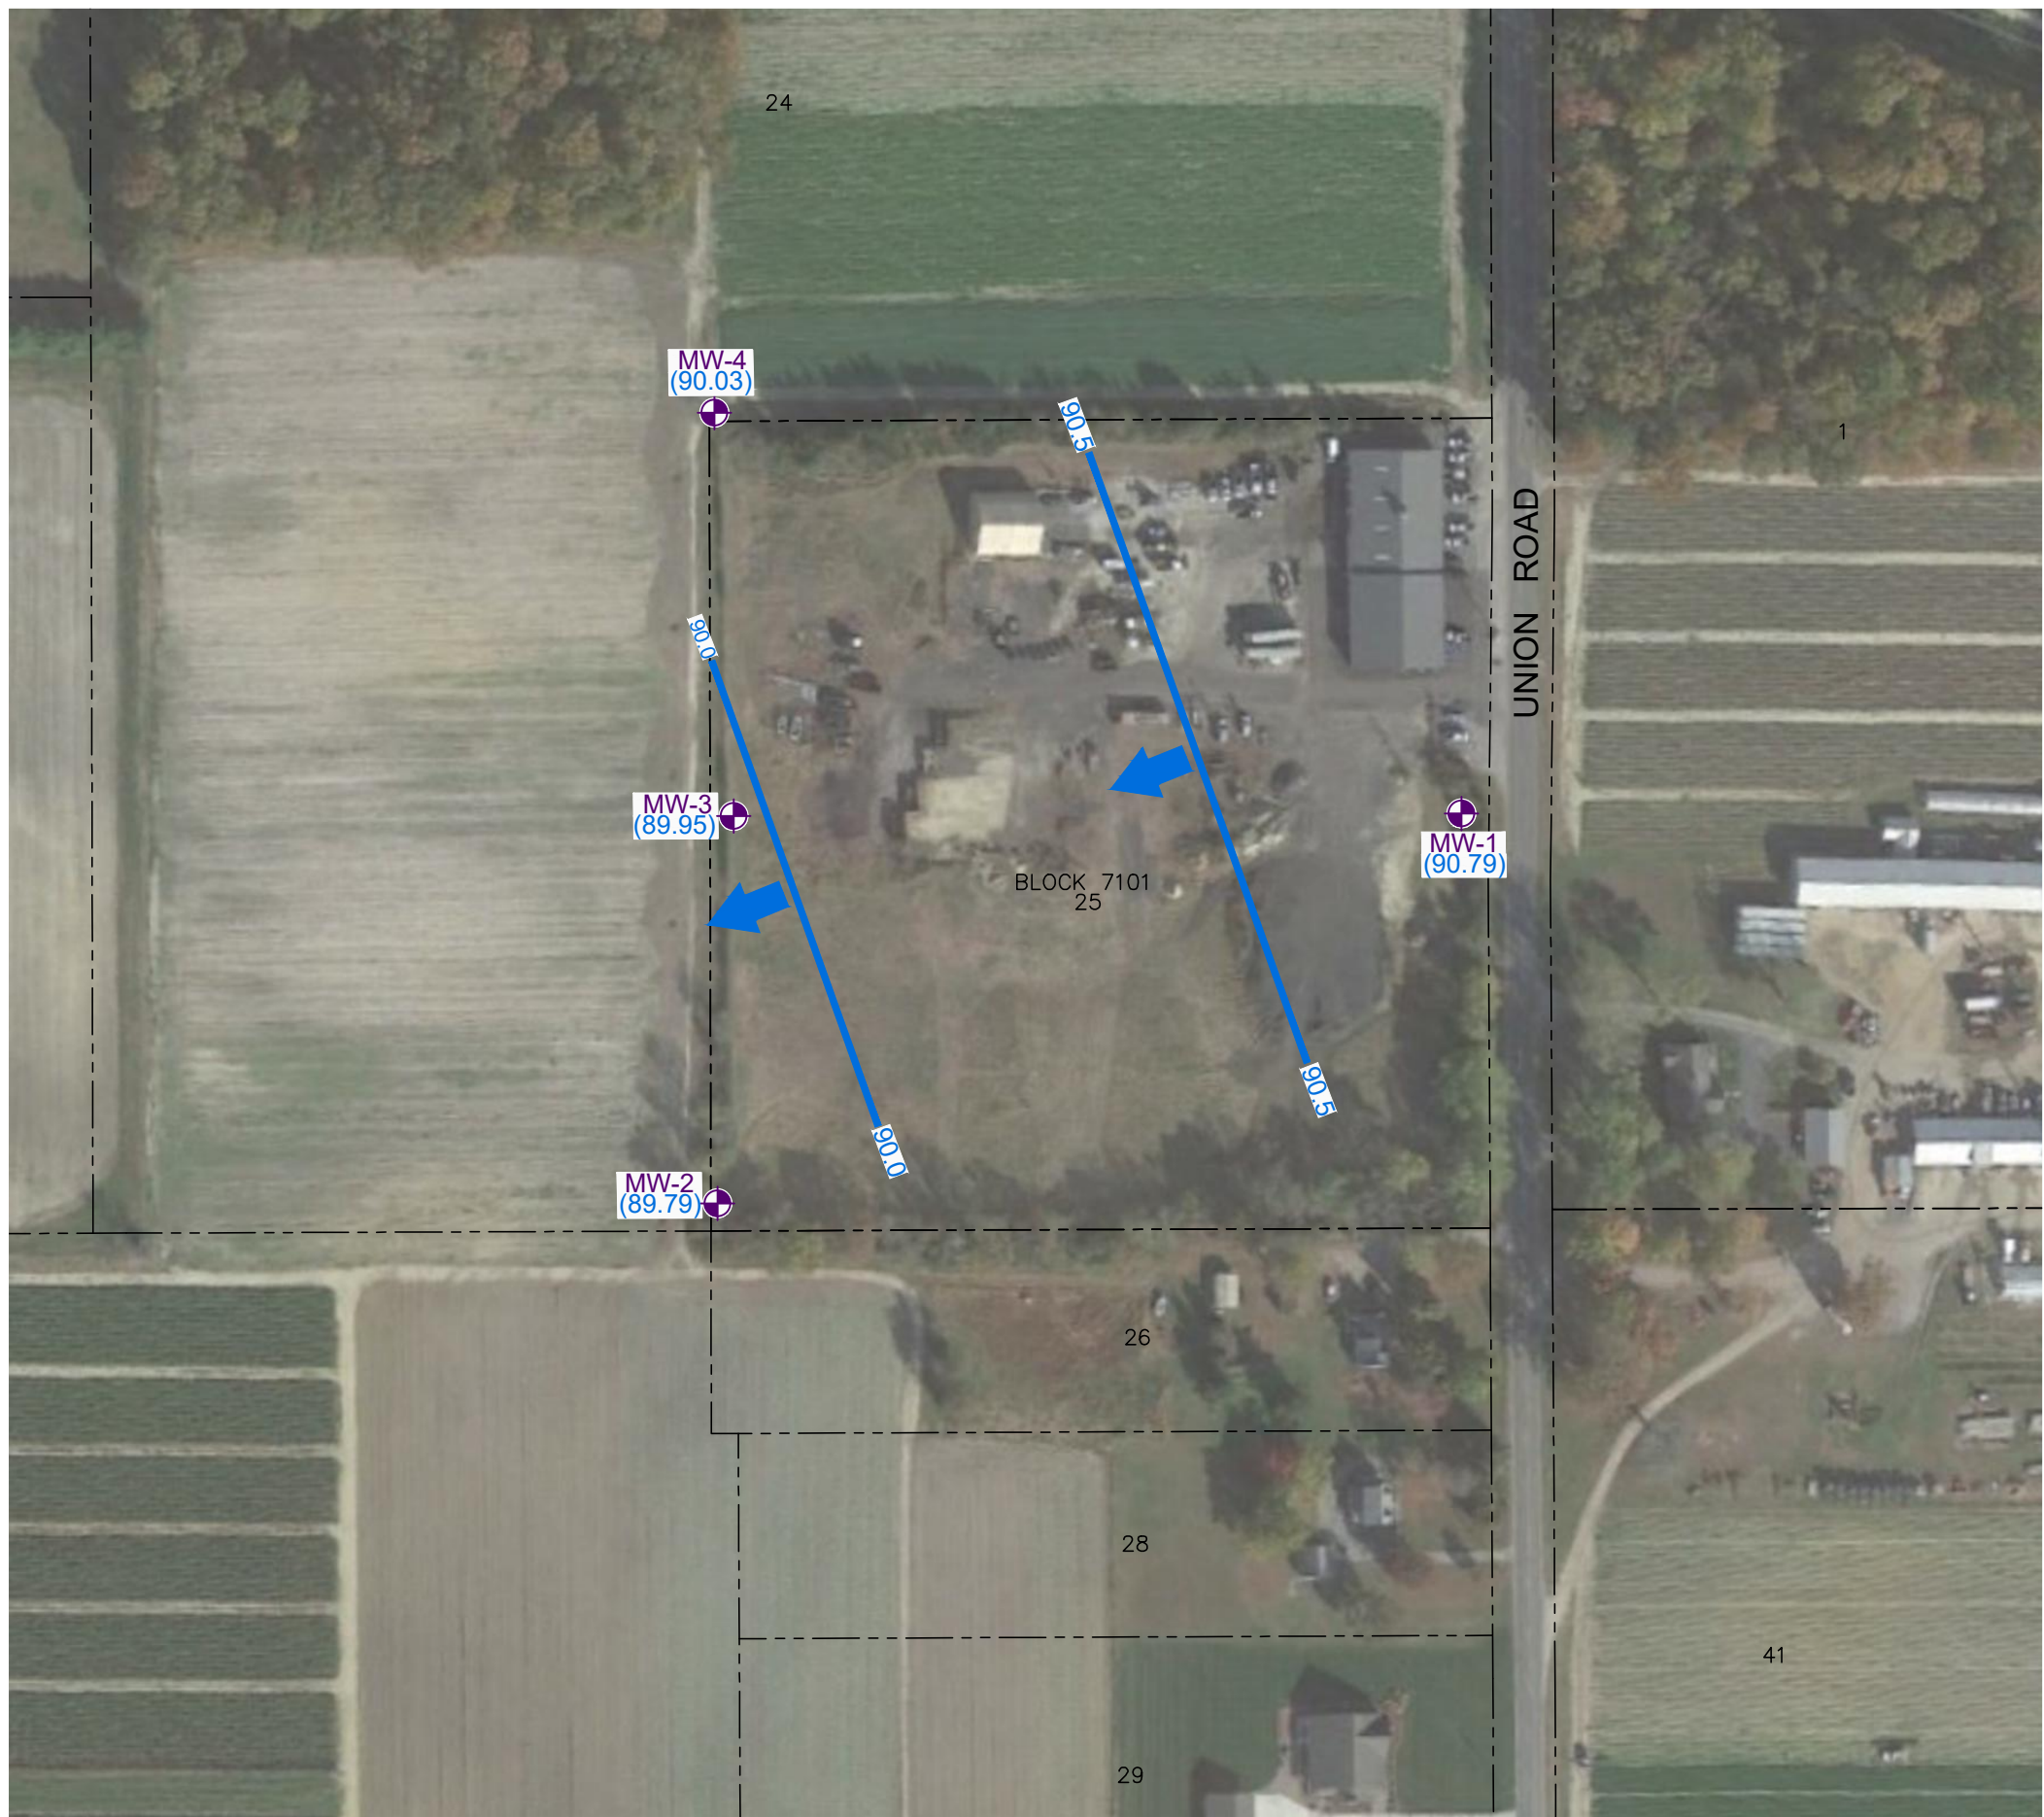
Figure 6

- LEGEND:
- MONITORING WELL LOCATION
 - TAX BOUNDARY
 - GROUNDWATER CONTOUR
 - GROUNDWATER ELEVATION
 - GROUNDWATER FLOW DIRECTION

GROUNDWATER ELEVATION CONTOUR
MARCH 19, 2019

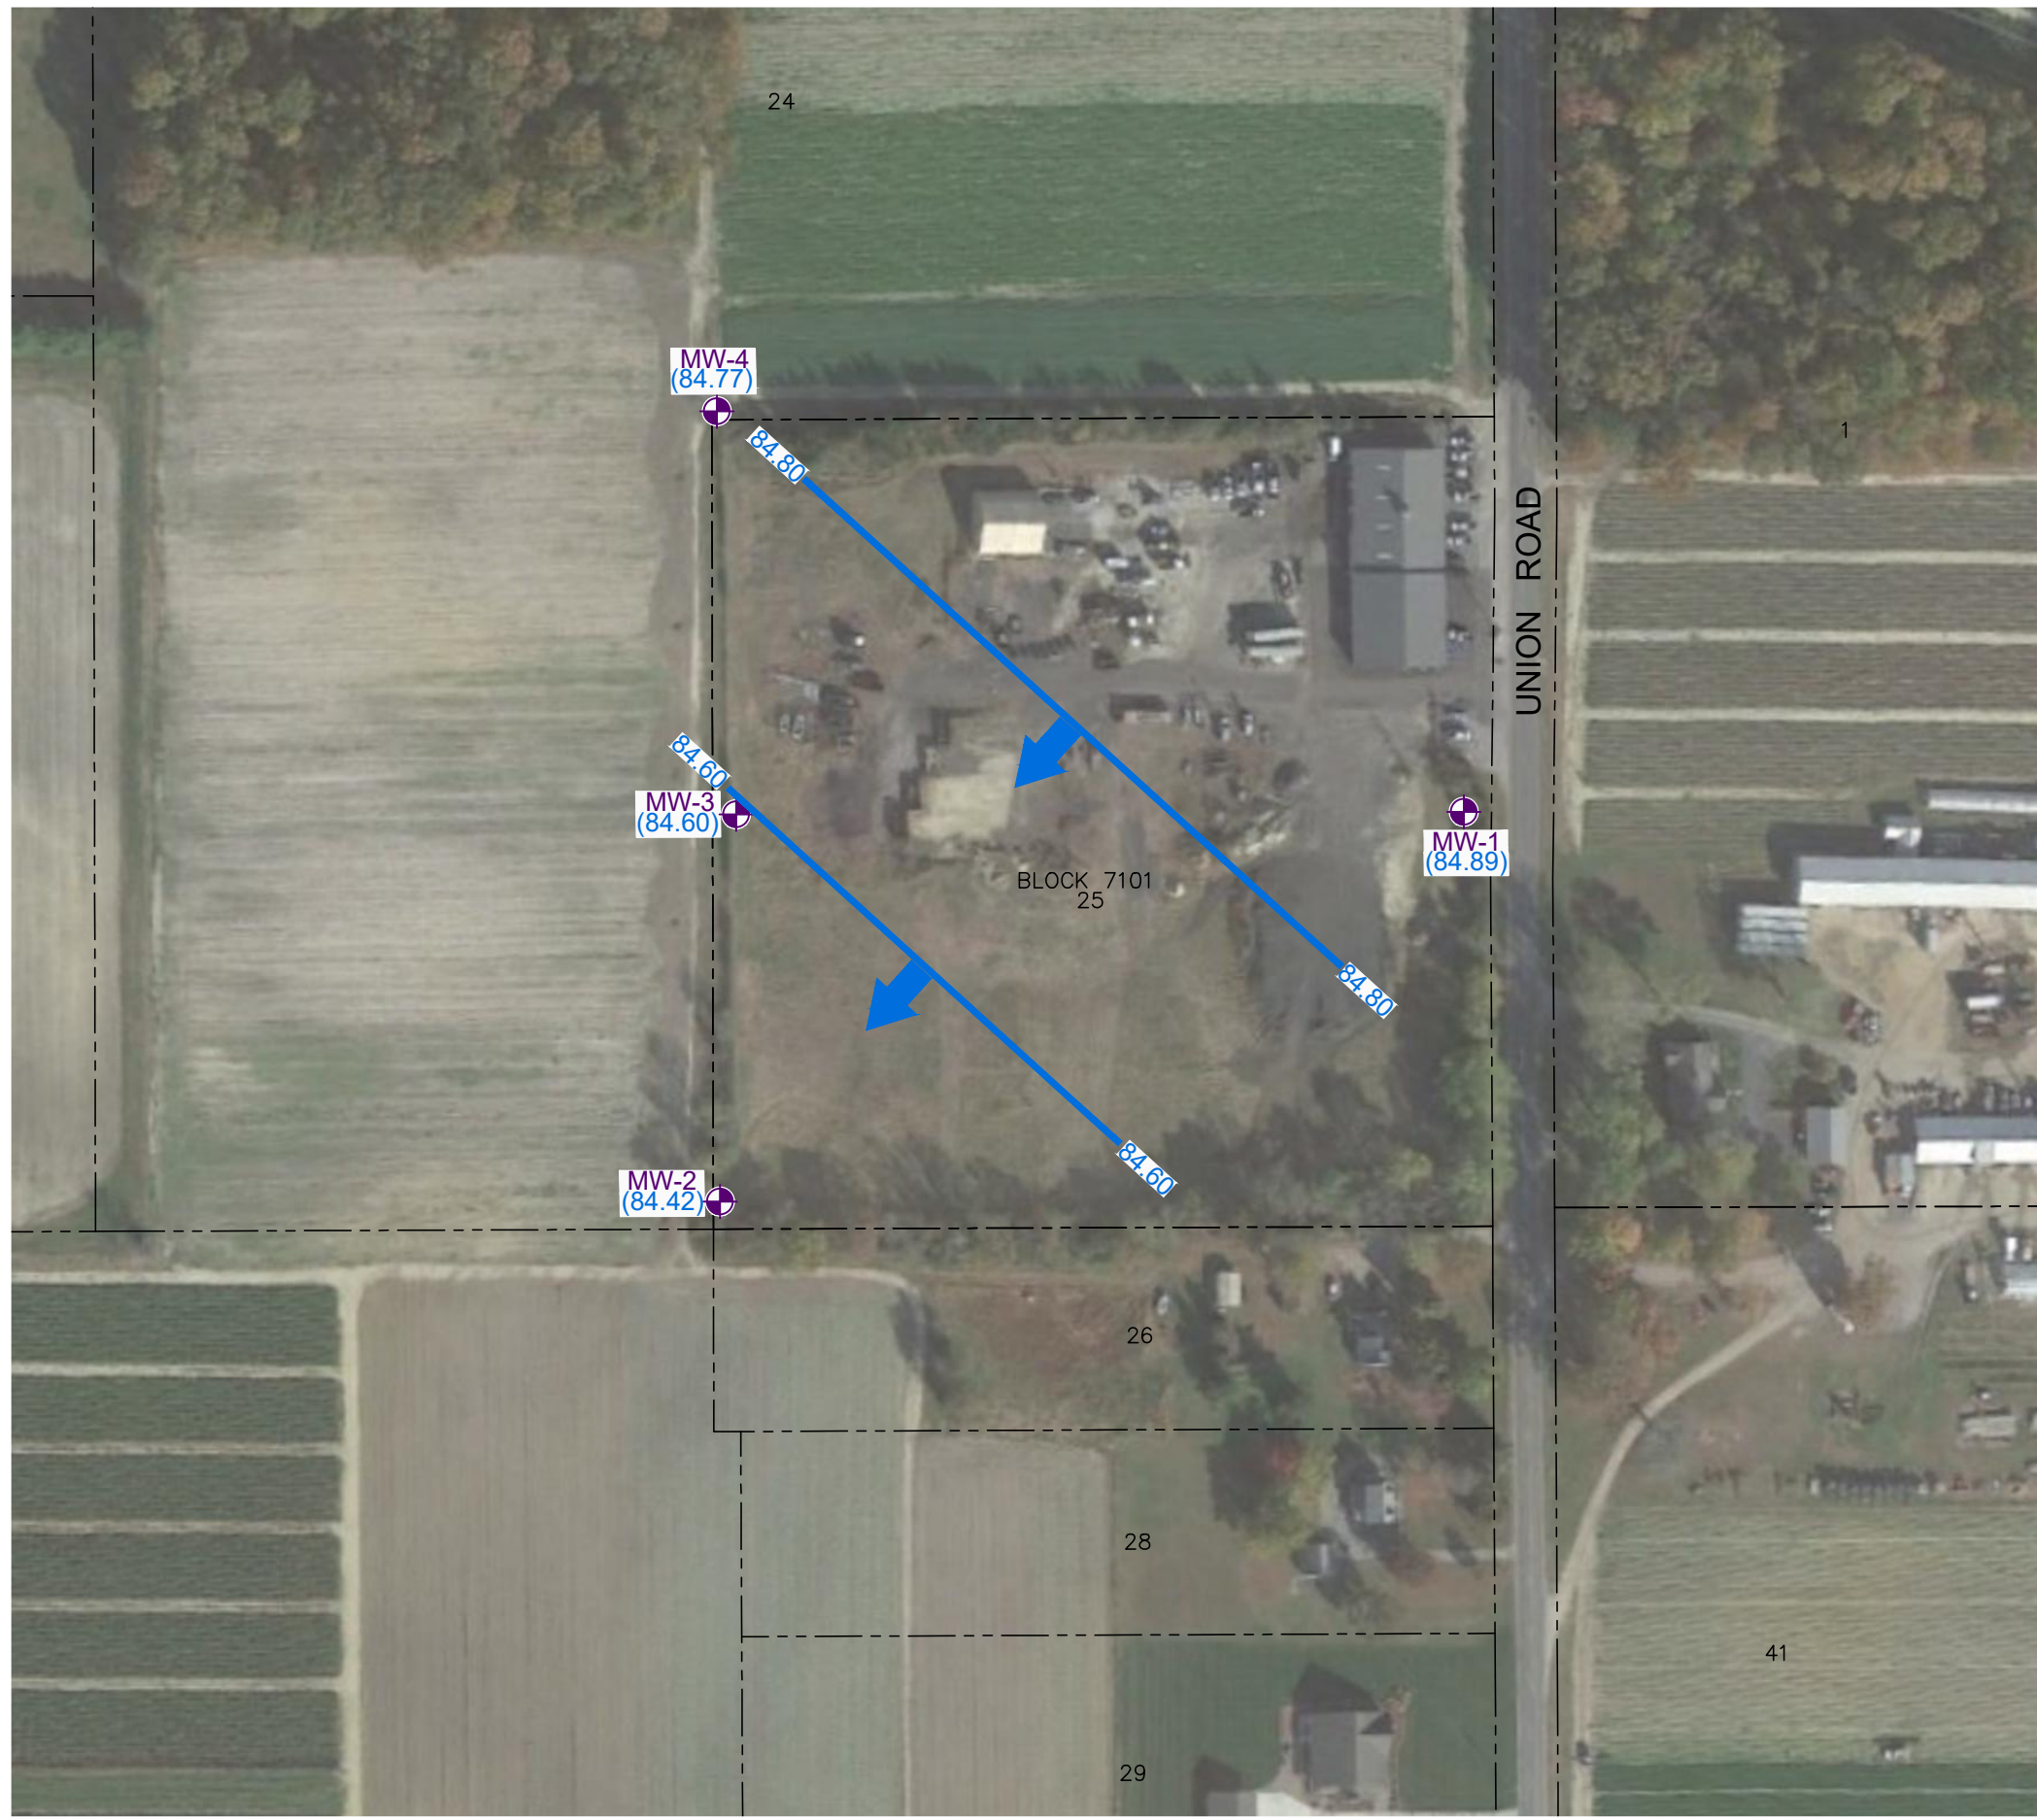
<p>GROUNDWATER ELEVATION CONTOUR JULY 22, 2022</p>	
<p>BUENA VISTA TOWNSHIP PUBLIC WORKS YARD 430 UNION ROAD BUENA VISTA TOWNSHIP ATLANTIC COUNTY, NEW JERSEY</p>	
<p>CALMAR Associates LLC.</p>	<p>DATE: SEPTEMBER 2022</p>
<p>NJDEP SRP PI # 032698 Ryan K. Seibert, LSRP</p>	<p>SCALE: 1" = 150'</p>
<p>Figure 7</p>
